**СУДОВА ЕКСПЕРТИЗА:
ПРОБЛЕМИ СЬОГОДЕННЯ ТА
ПЕРСПЕКТИВИ РОЗВИТКУ**

FRACTOGRAPHIC ANALYSIS OF THE DESTROYED SIDE FRAME OF THE TRUCK OF A WREIGHT WAGON

Purpose of the work. Analysis conditions nucleation and development destruction of the side frame freight wagon trolley.

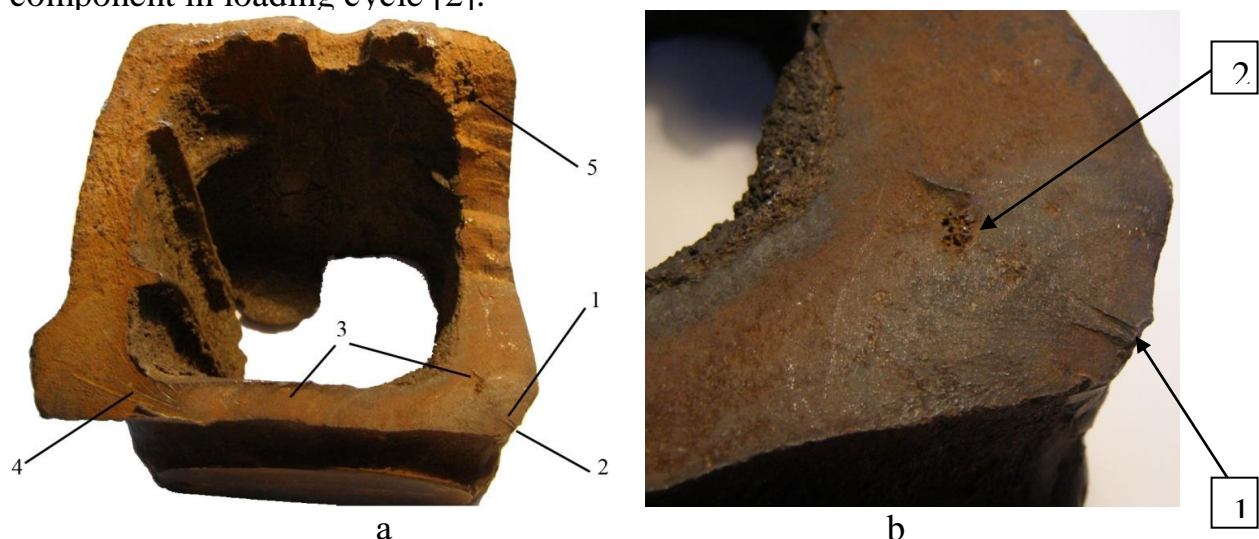
The elements found on the fracture surface (Fig. 1) indicate several reasons that led to a fracture of the side frame. An analysis of the location fatigue lines [3] and orientation of formed steps [4] indicate that the surface of foundry origin, with fragments of destroyed non-metallic inclusion (Fig. 1b, designation 2), should be considered primary focus of crack initiation. The character influence of a nonmetallic inclusion particle on the state of metal matrix was studied in detail in [5]. The formation steps (designation 1, Fig. 1b) from inclusion – matrix interface is justified, and their gradual disappearance indicates growth of fatigue crack along several surfaces [2]. Moreover, after combining the fronts of fatigue crack, the growth process was already carried out with increasing speed, as evidenced by distance between the places where the crack stops [4] (designation 3, fig. 1a,b). As the area of damaged metal increases due to propagation of the fatigue crack and, as a result, the intensity of acting stresses increases [5], there is an increase static component in loading cycle [2].

Fig. 1 – The location of structural elements fracture surface of side frame:

(1) - steps, (2) - crack exit to the surface, (3) - places where the crack stops and moves, (4) - crests, (5) - pores in general view (a) and region formation of focus fatigue crack (b): (1) - steps, (2) - non-metallic inclusion

In addition an increase intensity of acting stresses from decrease in the cross-sectional area of frame elements during fatigue, additional acceleration of the fracture process was obtained from presence of foundry defects. This is evidenced by the formed steps on fracture surface and change in shape of front growing crack (Fig. 1b).

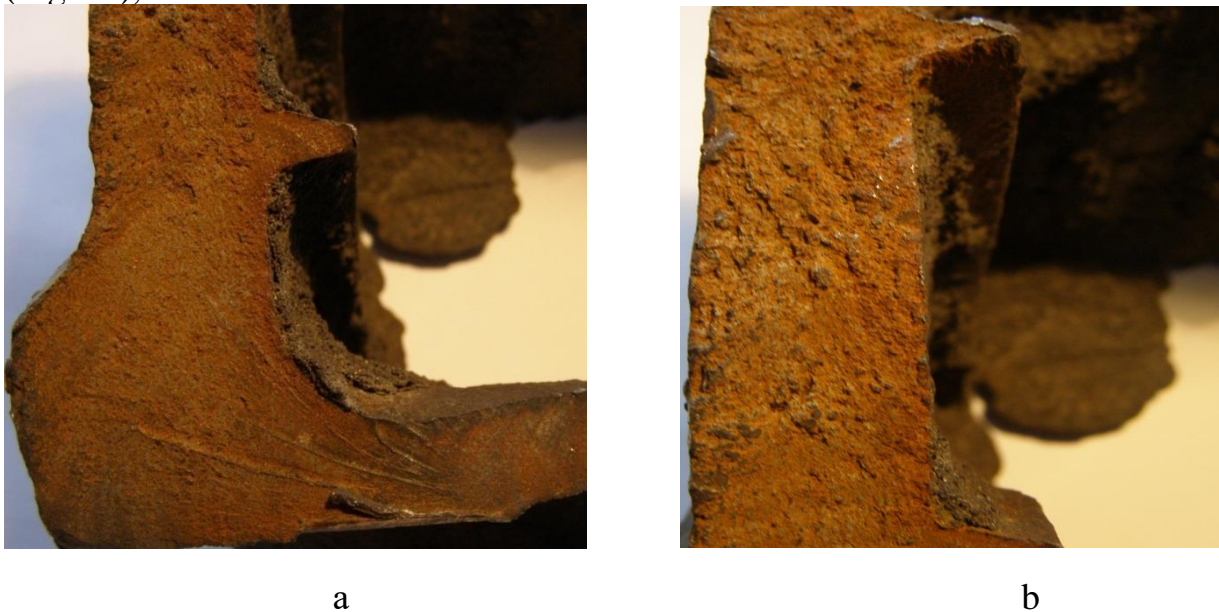
Based on this, the growth plane of fatigue crack (designation 4, Fig. 1a, Fig. 2a), elements similar to radial section are detected during the static destruction metal material [5]. Indeed, in a more detailed analysis, the detected scars and fine facets [6], indicating the acceleration of crack growth, allow us to determine direction of predominant movement crack front. The location of crack nucleation center and the orientation of acting stresses, the crack growth conditions on the side walls of frame should be somewhat different. Indeed, after the front of growing crack reaches the first stiffener on the left side wall, it is quite difficult to detect signs of fatigue fracture in the kink (Fig. 1a). For the right side of side frame (Fig. 1a), the crack nucleation site is located on the extension of the side wall.

Fig. 2 – The ridges

(designation 4, Fig. 1a) - (a) and fibrous component of fracture in the form of pits (b)

Further, in the process of fatigue after a decrease in the cross section of product, by about 20 - 25%, crack growth is accelerated, with the simultaneous appearance of signs static fracture of the metal: crests (Fig. 2a), pits and fibrous component in fracture (Fig. 2b).

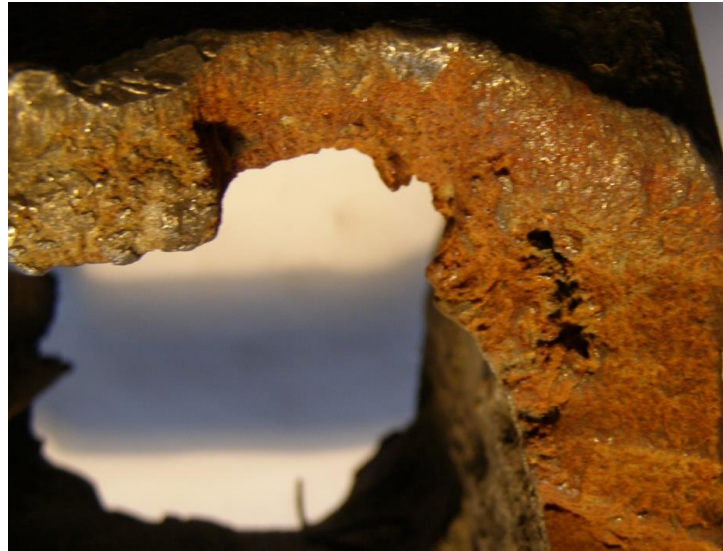
Based on this, the growth of fatigue crack was carried out in one plane to the middle of the frame wall. After that, the change in stress during the operation of trolley frame or another influence such as the development of local hardening processes during strain aging of metal [7] at the mouth of crack is evident; a growing crack moved to an almost parallel plane. As a result of this, the signs of fatigue failure are again quite unexpectedly detected, although to a greater extent they correspond to areas with a high degree of cyclic overload. To a certain extent, the indicated crack growth could continue to the upper horizontal part, if not for significant porosity of the metal (designation 5, Fig. 1a, Fig. 3). The presence of indicated porosity, contributing to a local decrease in fracture resistance of the metal [2], can change the crack growth conditions. The structural features of fracture surface indicate an almost complete transition of the crack growth process to the phase of dynamic destroy [2] of the side frame. A similar fracture pattern was found on the left side wall of frame. The dynamic destroy phase began from middle of the wall towards upper horizontal part. Based on analysis of fracture surface, the discovered complex nature of the initiation fatigue crack and the rather rapid formation of a united front (completion of propagation steps, Fig. 3) indicate the total effect of several factors. Against the

background of a possible overload trolley, first of all, defects in the foundry became the nucleation point of fatigue failure.

Fig. 3 – Pores - casting defects (designation 5, Fig. 1a) in manufacture of side frame

2. The focus of fatigue crack was the volume metal with exceeding limits of regulatory documentation for manufacture of the side frame trolley for non-metallic inclusions and concentrated porosity.
